**NASA TM X-1195**

**ANALYSIS OF AN EMERGENCY  
DECELERATION AND DESCENT OF THE  
XB-70-1 AIRPLANE DUE TO ENGINE DAMAGE  
RESULTING FROM STRUCTURAL FAILURE**

*by Chester H. Wolowicz*

*Flight Research Center  
Edwards, Calif.*

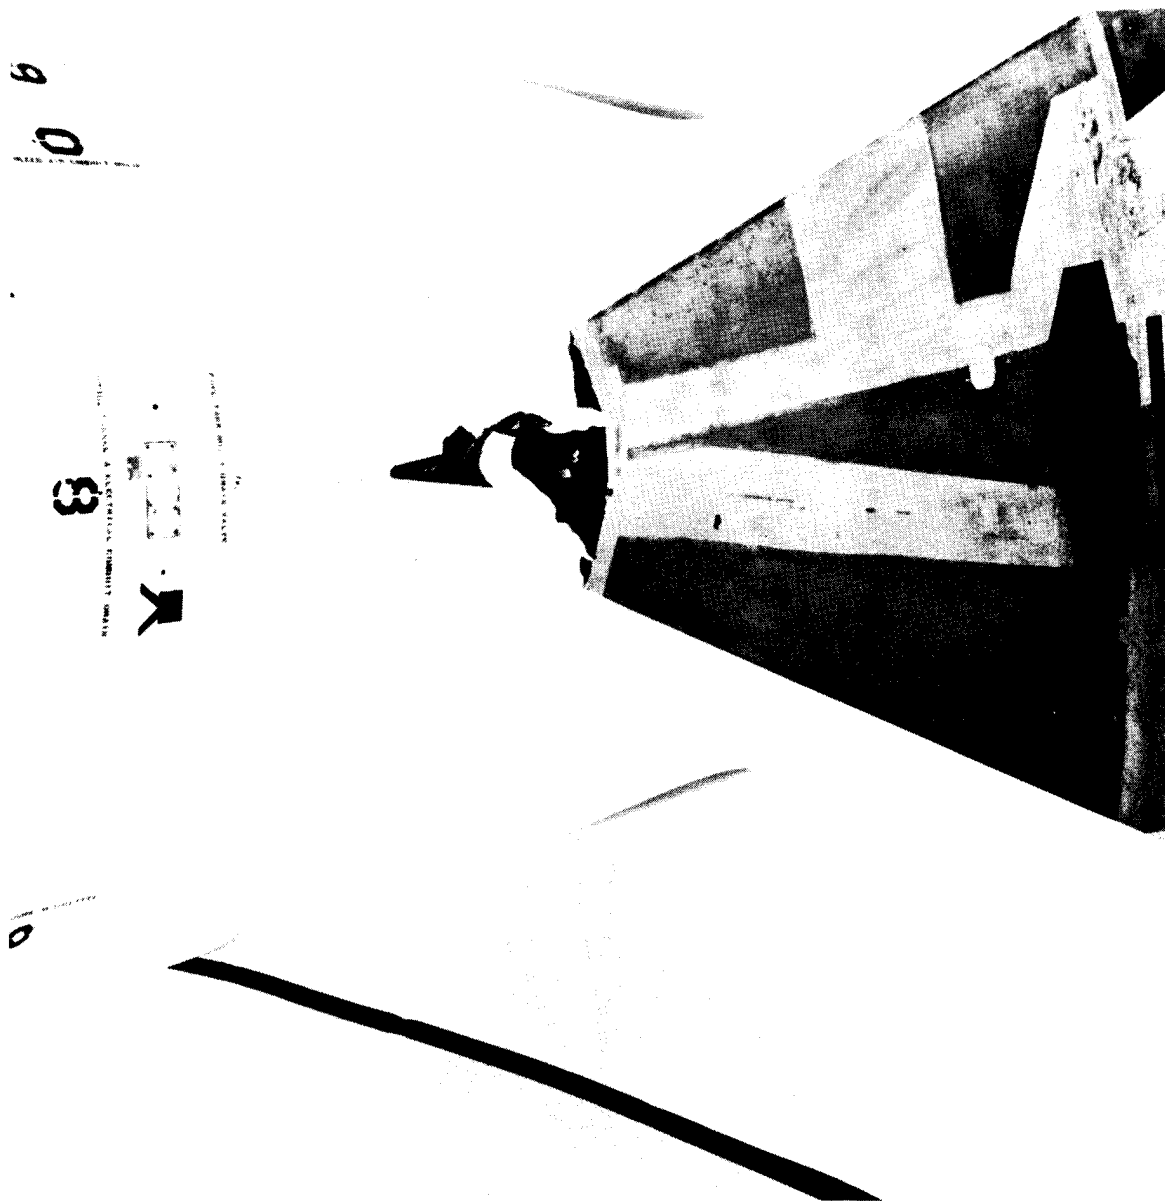
As deduced from postflight inspections of the aircraft, analysis of flight data, study of flight-monitoring notes, and information supplied by the manufacturer (ref. 1), the initial duct unstart of the emergency portion of the flight was caused by a stall of the No. 5 engine (in the right duct) resulting from ingestion of pieces of the wing apex into the right duct. Figure 3 is a postflight photograph of the damaged apex section of the wing.

Figure 3. - Postflight photograph of disintegrated apex of wing. XB-70-1; flight 12.

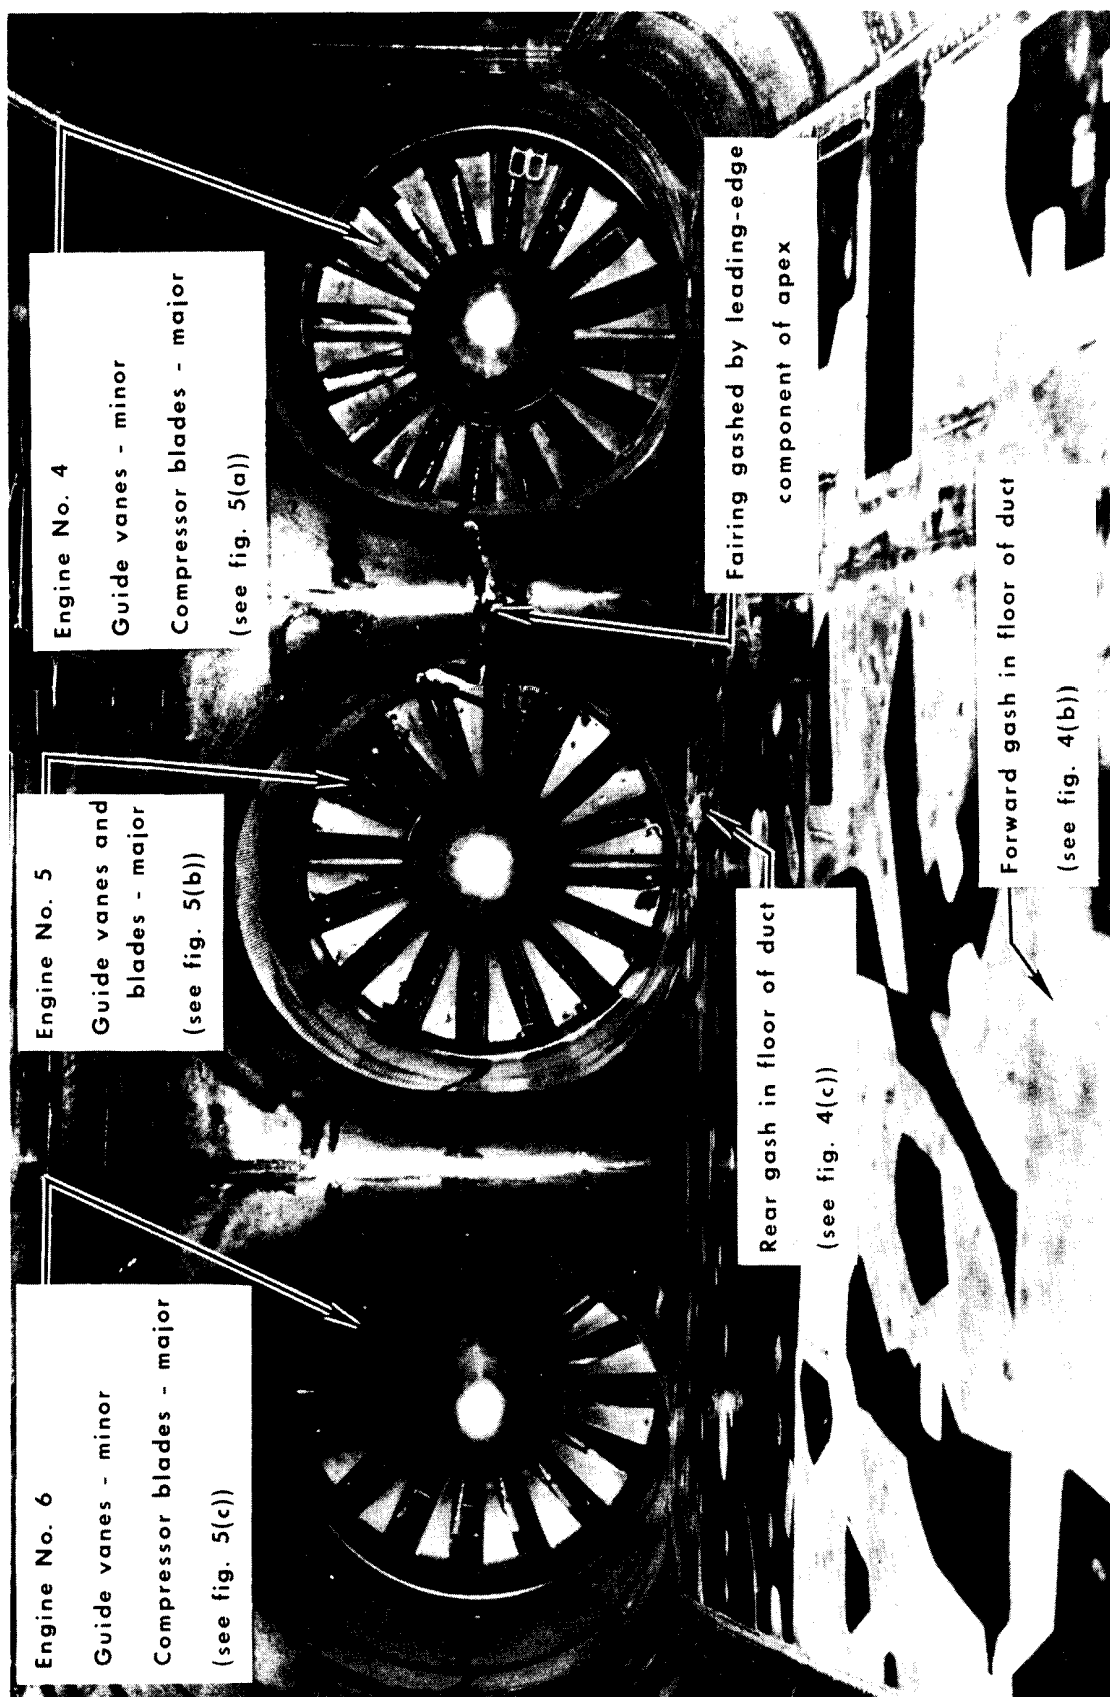
Figure 4. - Right-hand-duct damage.

The damage done to the right duct and its engines is shown in figures 4(a) to (c) and 5(a) to (c). Fortunately, time histories of propulsion and aerodynamic parameters were obtained for the entire duration of the ensuing emergency. Time histories of the pertinent propulsion parameters for both ducts are shown in figure 6. The more pertinent portions of the aerodynamic time histories obtained from the manufacturer's tabulated data are shown in figures 7(a) and 7(b).

(a) Overall view encompassing areas damaged by disintegrated wing apex.

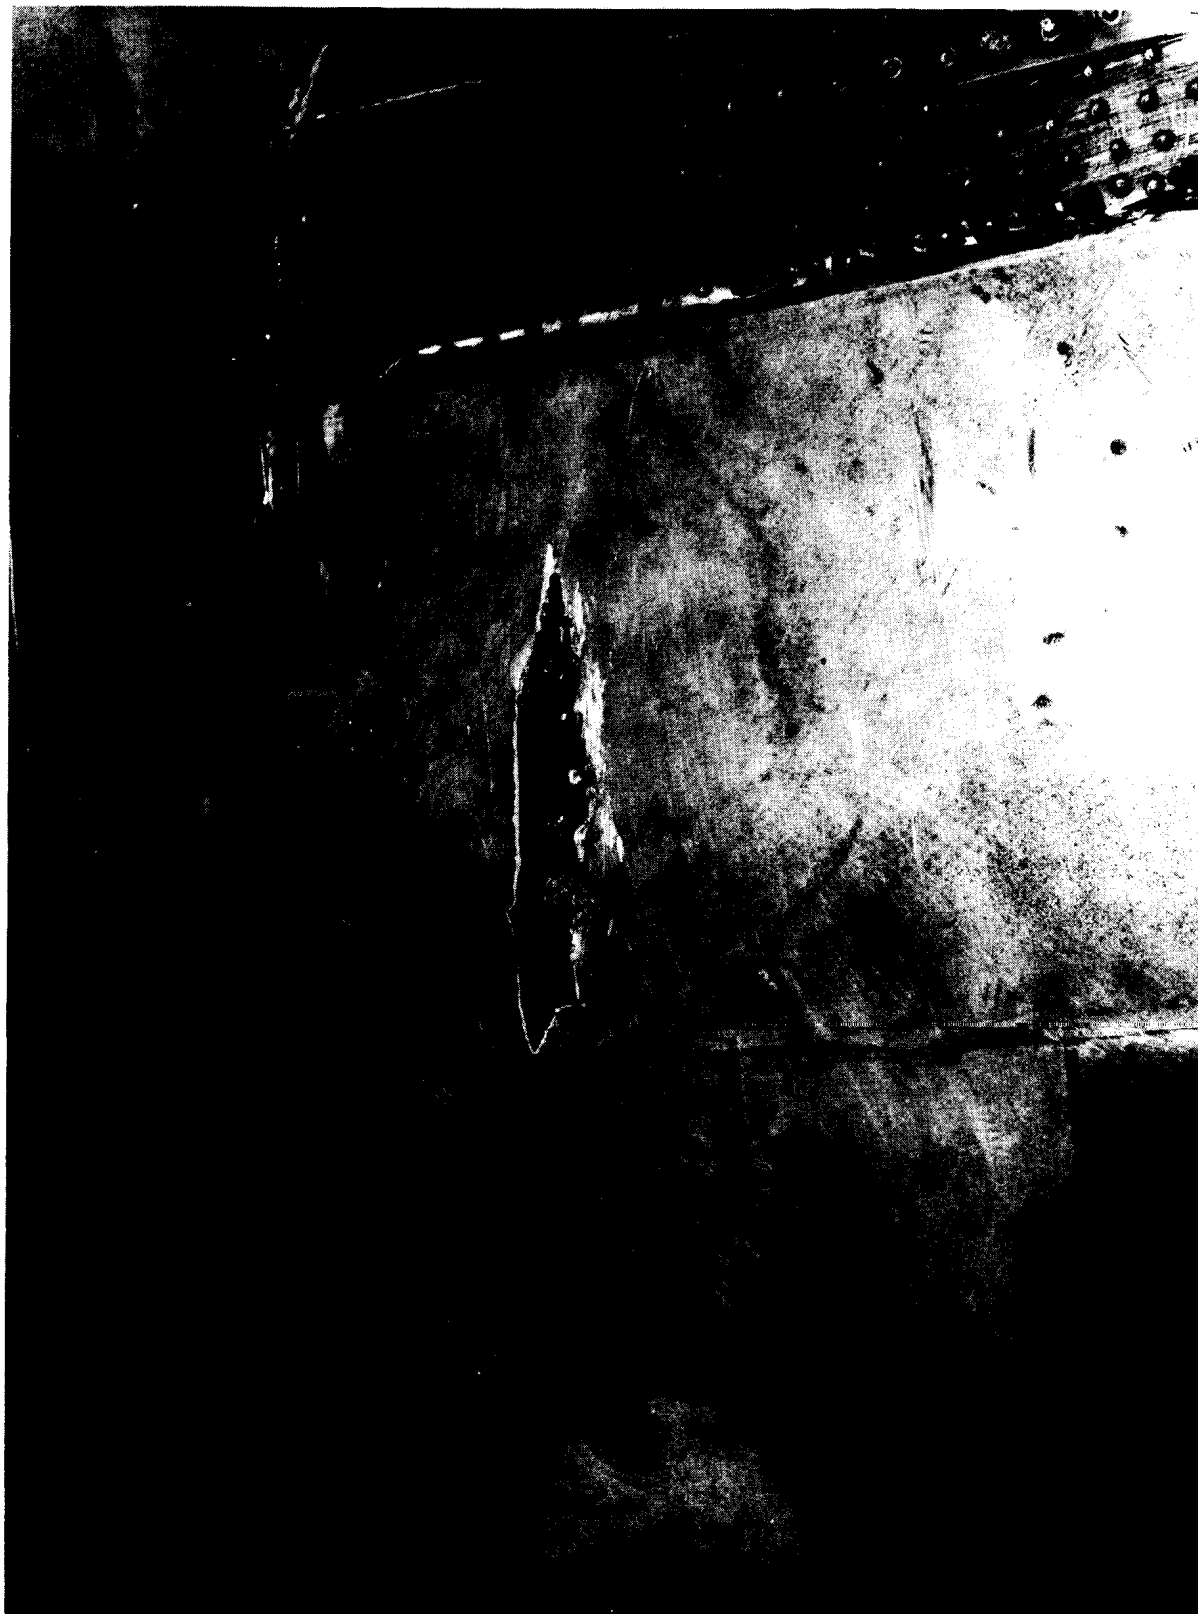
Figure 4. - Continued.

(b) Detailed view of forward gash in floor.

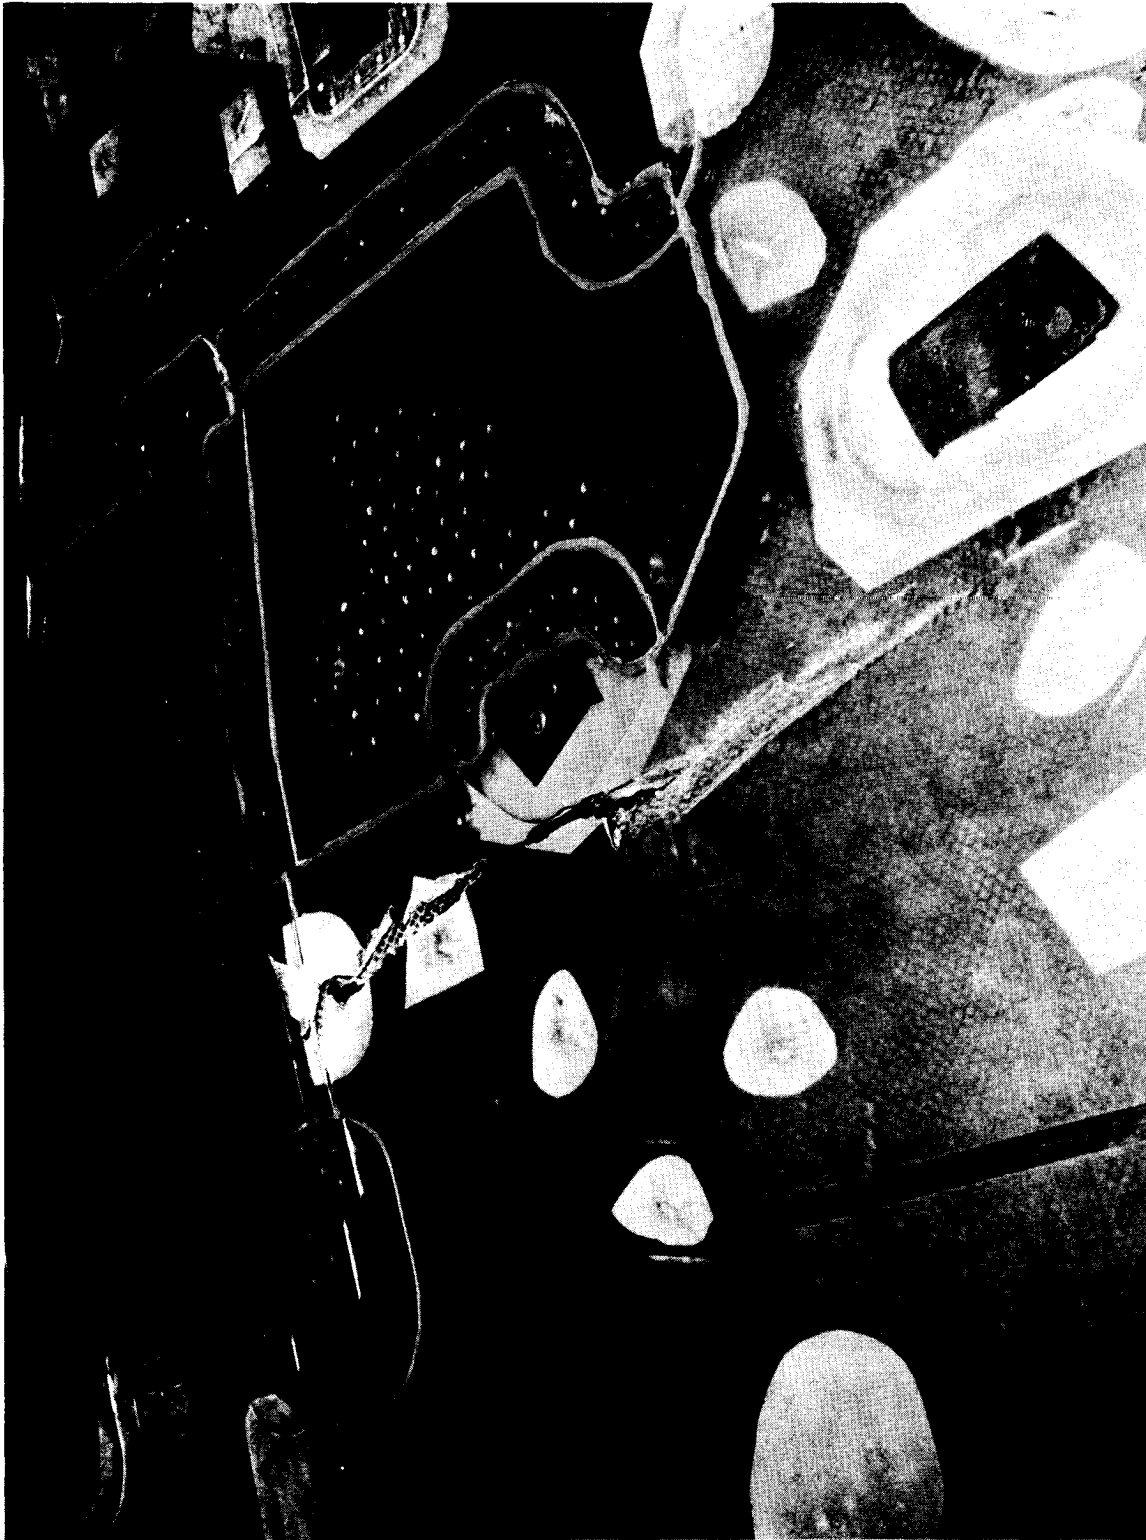
Figure 4. - Concluded.

(c) Detailed view of rear gash in floor.

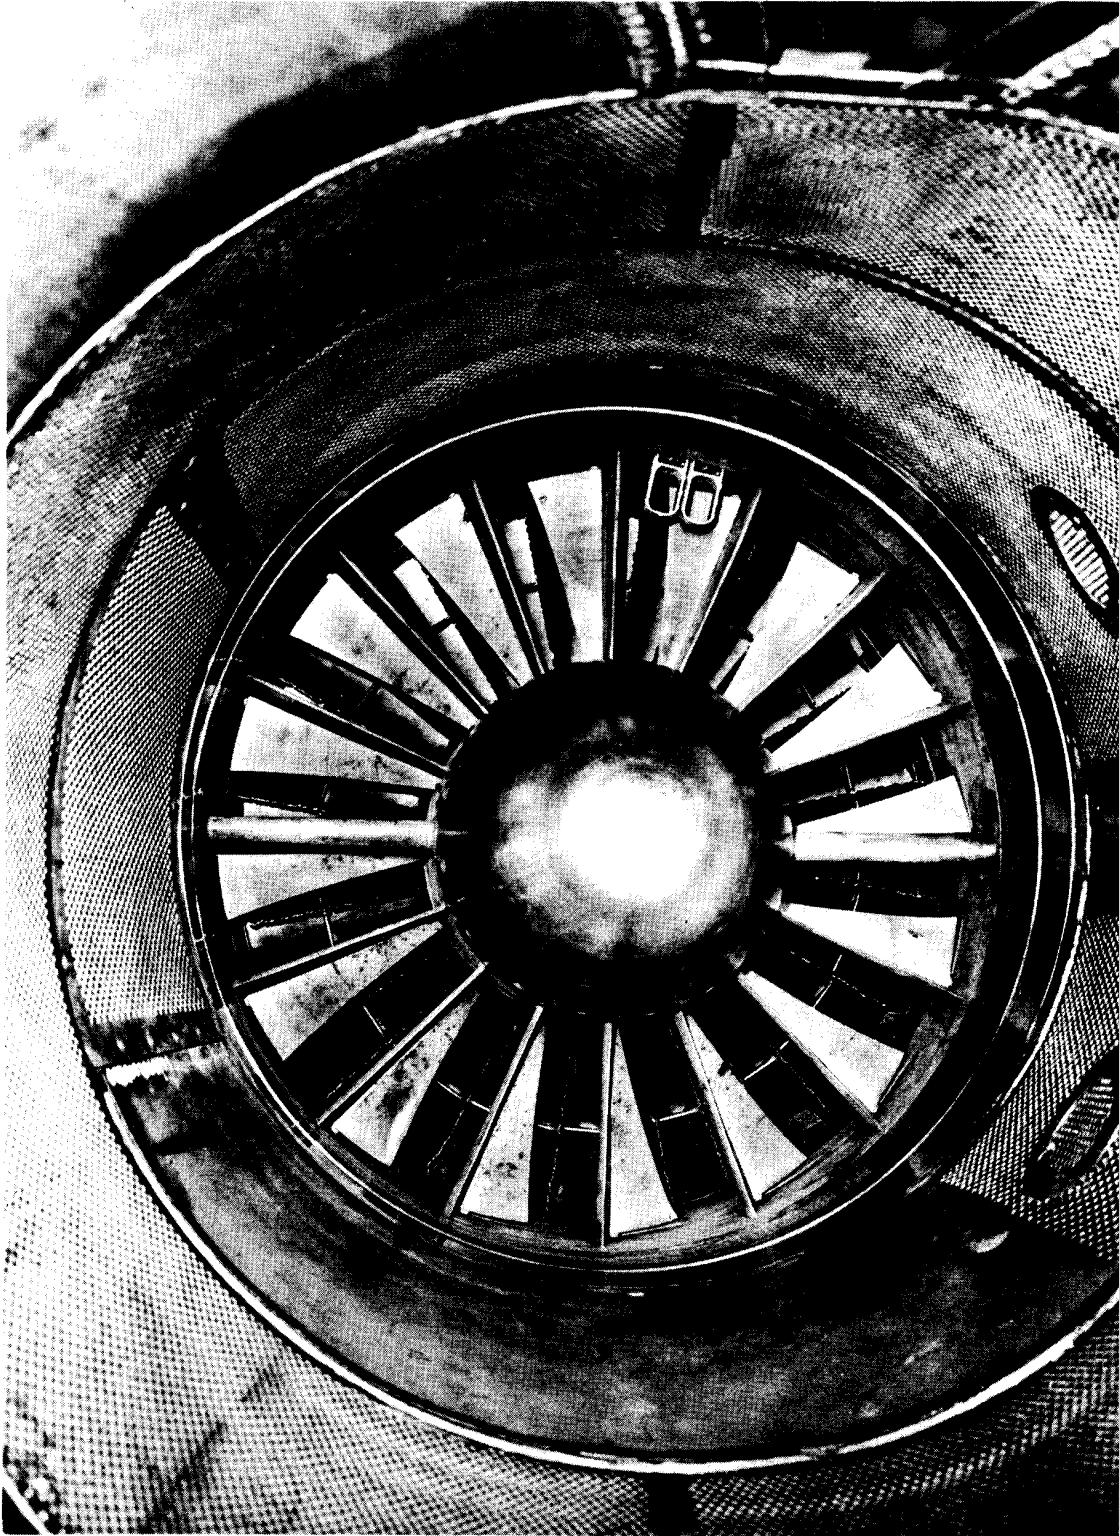
(a) No. 4 engine.  
Figure 5. - Detailed views of engine damage.

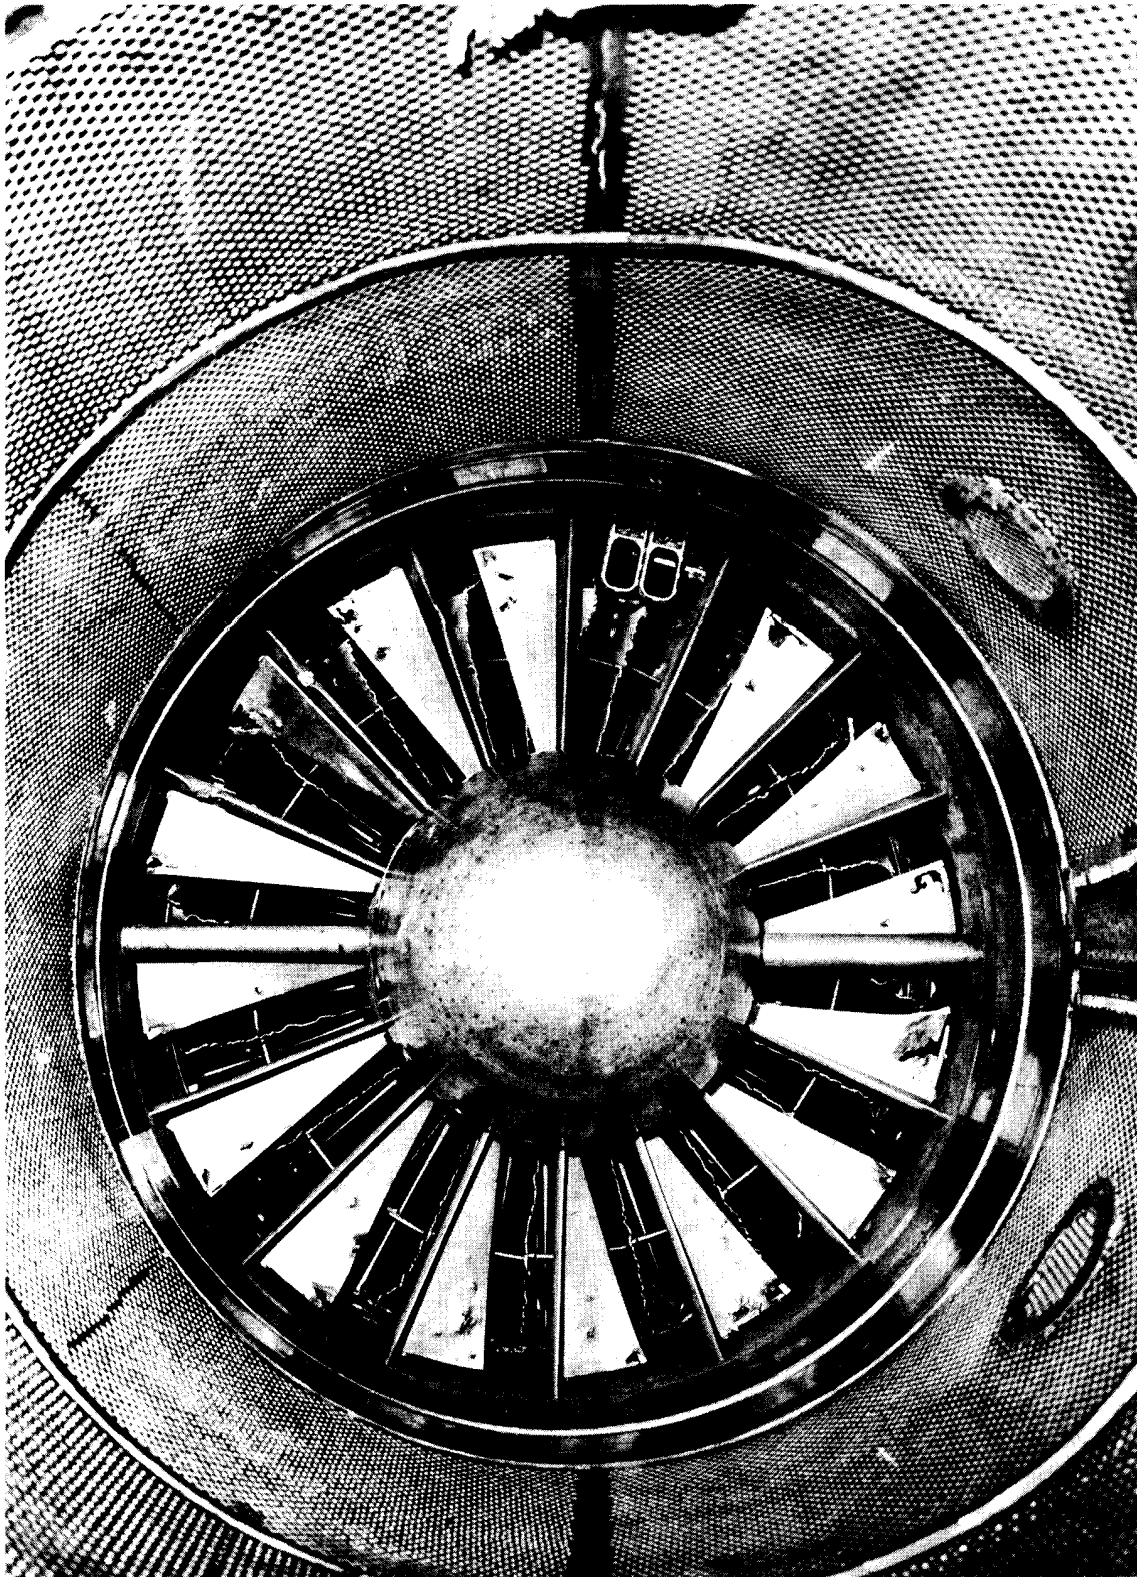
Figure 5. - Continued.

(b) No. 5 engine.

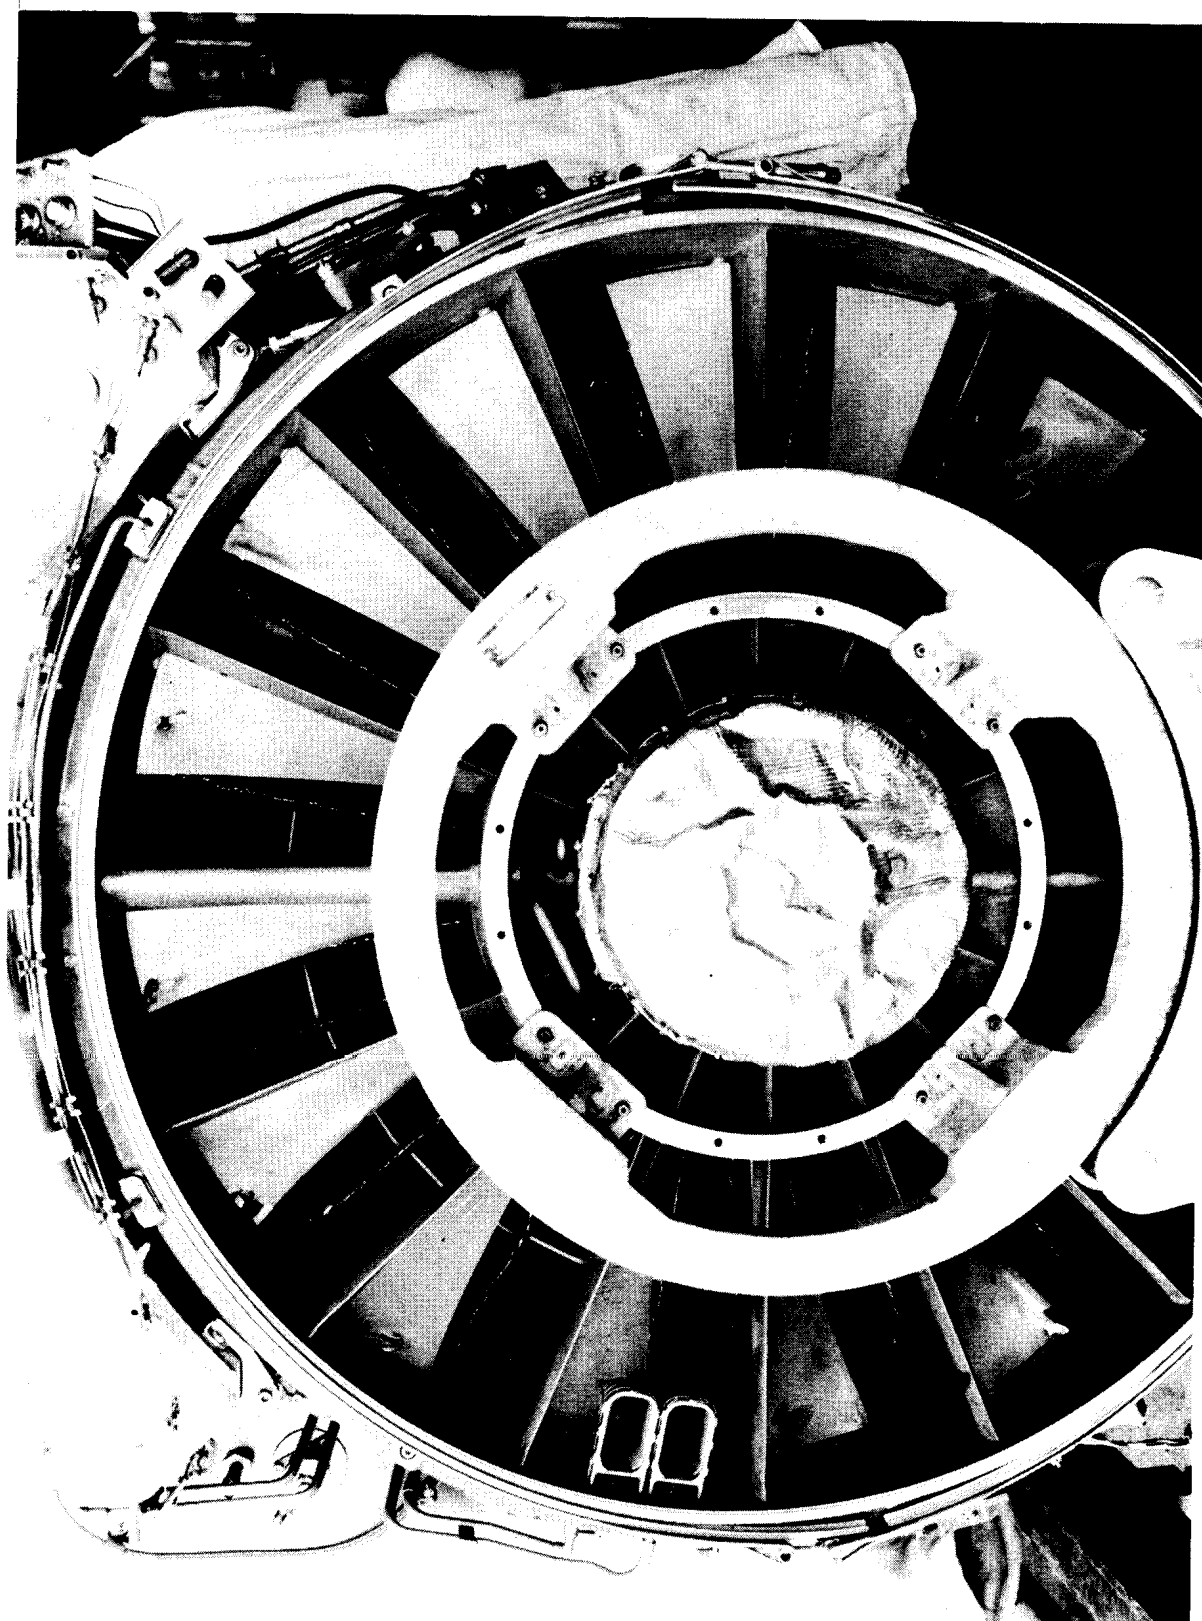
Figure 5. - Concluded.

(c) No. 6 engine removed from the aircraft installation. Center fairing dome and other fairings removed.
